# Manhole Inspection Summary

Manhole # S31I\_\_006MH

Insp Date: **10/29/08 2:44 PM**

**Location** Address: **22 s eutaw st**

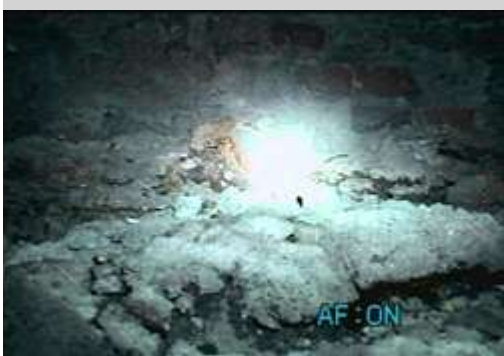
Defect 2

Condition: ☐ Sound ☐ Cracked ☐ Root Intrusion ☐ Deteriorated ☐ Leaks ☒ **Debris**

bench cond debris

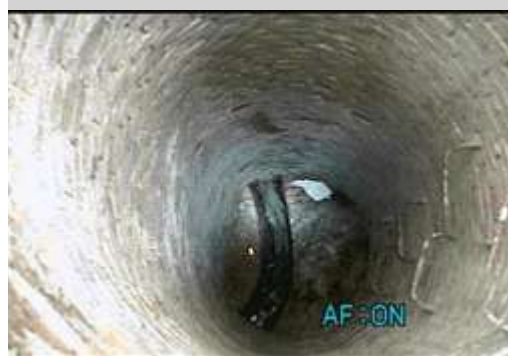
Defect 3

Infiltration: ☐ None ☐ Joint ☐ Cracks ☐ Mortar ☐ Roots ☒ **Wall**

barrel flow wall

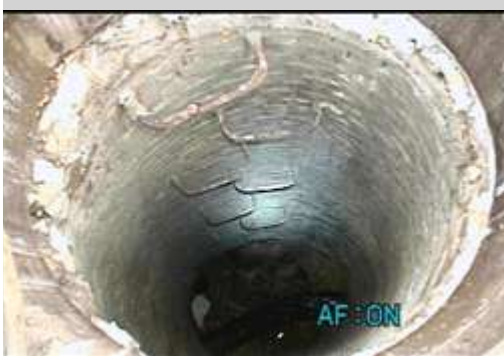
Defect 1

**Steps** Count: **8** Missing: **3** ☒ **Corroded**

corr steps

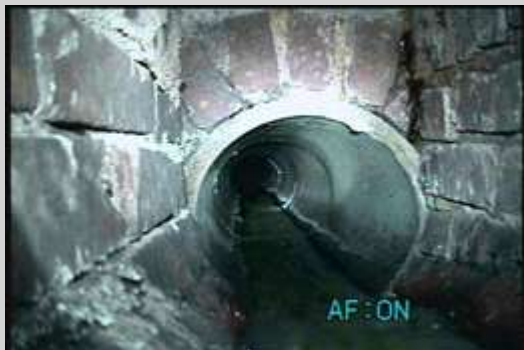
12 O'Clock Outflow

10 in. Circular Gravity Sewer  
Pipe Out @ 12 O'Clock

Invert Depth: **16.10** (ft.) Flow Characteristics: **Fast**

Infiltration: **None** Pipe Seal Cond: **Unknown**

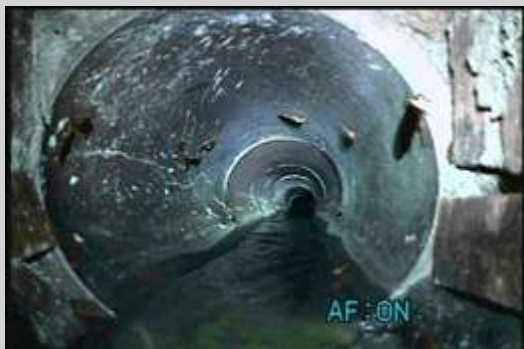
7 O'Clock Inflow

10 in. Circular Gravity Sewer  
Pipe In @ 7 O'Clock

Invert Depth: **15.41** (ft.) Flow Characteristics: **Fast**

Infiltration: **None** Pipe Seal Cond: **Unknown**
